# Bearing failures and their causes

## Bearing failures and their causes

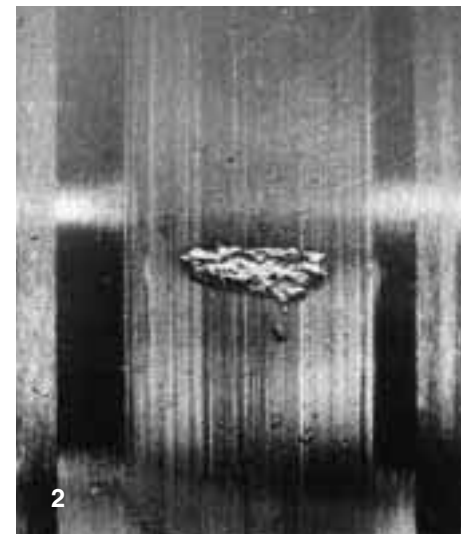
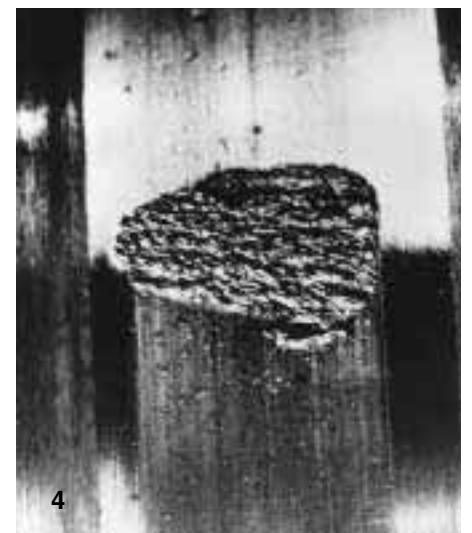
**Figs 1–4** Progressive stages of flaking

magnitude of the load. Fatigue is the result of shear stresses cyclically appearing immediately below the load carrying surface. After a time these stresses cause cracks which gradually extend up to the surface. As the rolling elements pass over the cracks fragments of material break away and this is known as flaking or spalling. The flaking progressively increases in extent (figs 1 to 4) and eventually makes the bearing unserviceable.

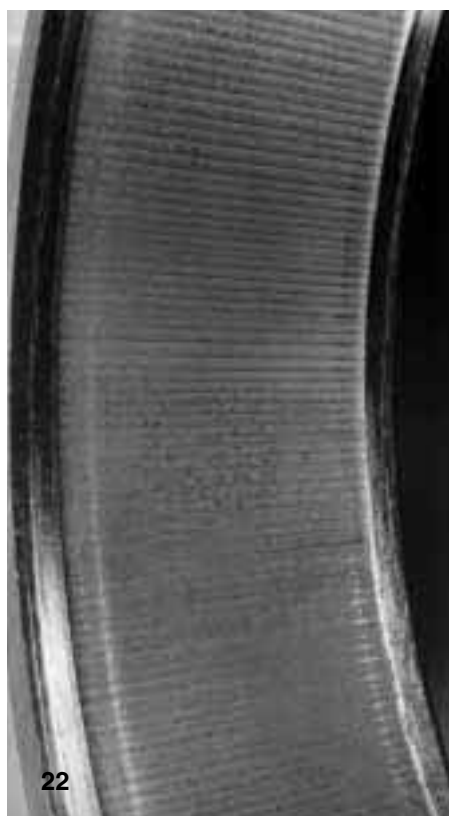
**Fig 22** Outer ring of taper roller bearing damaged by vibration during operation

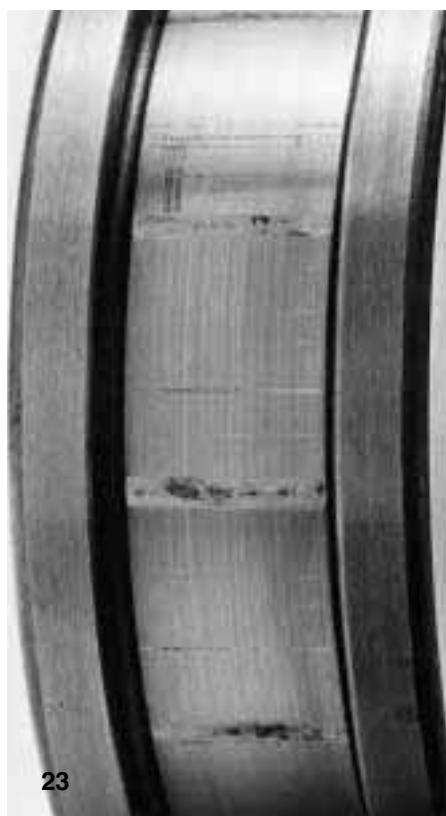
**Fig 23** Vibration damage to the ring of cylinder roller bearing. The damage has arisen while the bearing was not running. It is evident, from the fainter fluting discernible between the pronounced depressions with corrosion at the bottom, that the ring has changed position for short periods

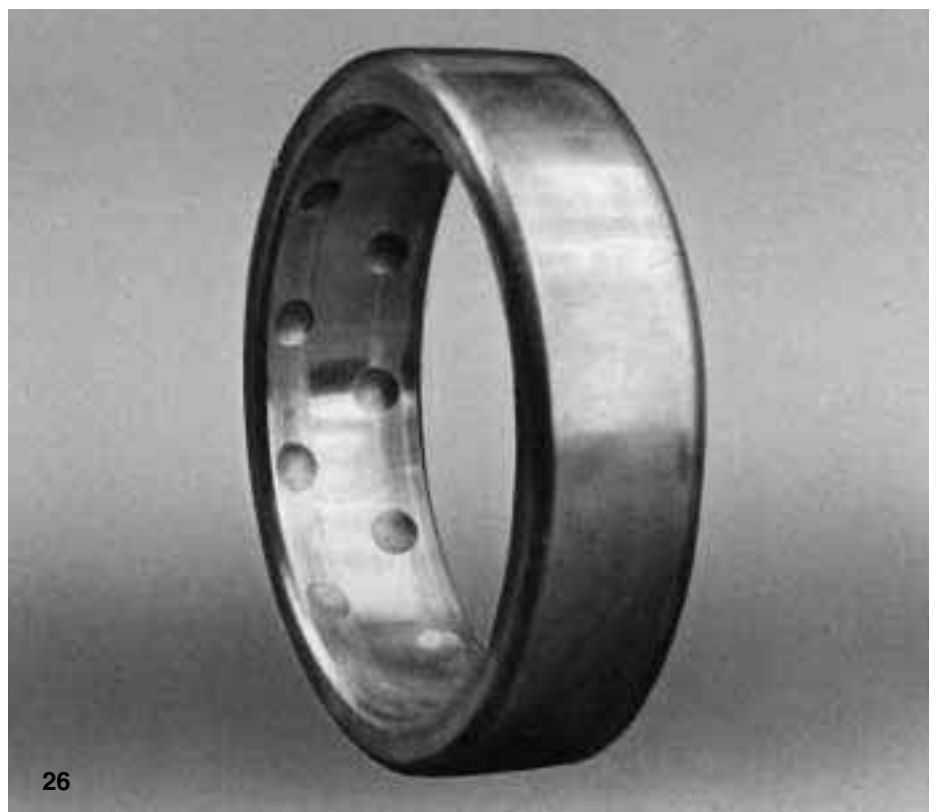
26

**Fig 26** Outer ring of a self-aligning ball bearing damaged by vibration. The bearing has not rotated at all

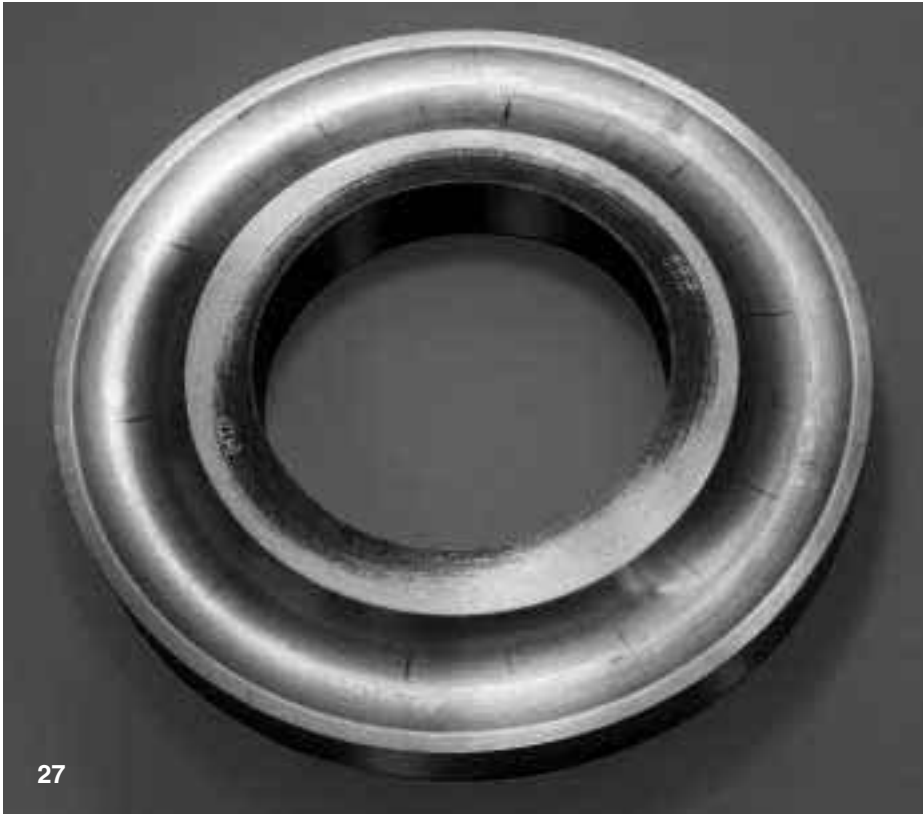
**Fig 27** Washer of a thrust ball bearing subjected to overloading while not running. The indentations are narrow and radially aligned, not sphered as in radial ball bearings

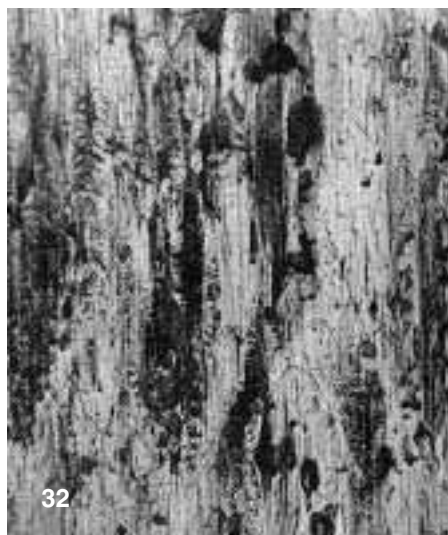
**Fig 32** Smearing on the surface of a roller from a spherical roller bearing – 100 × magnification

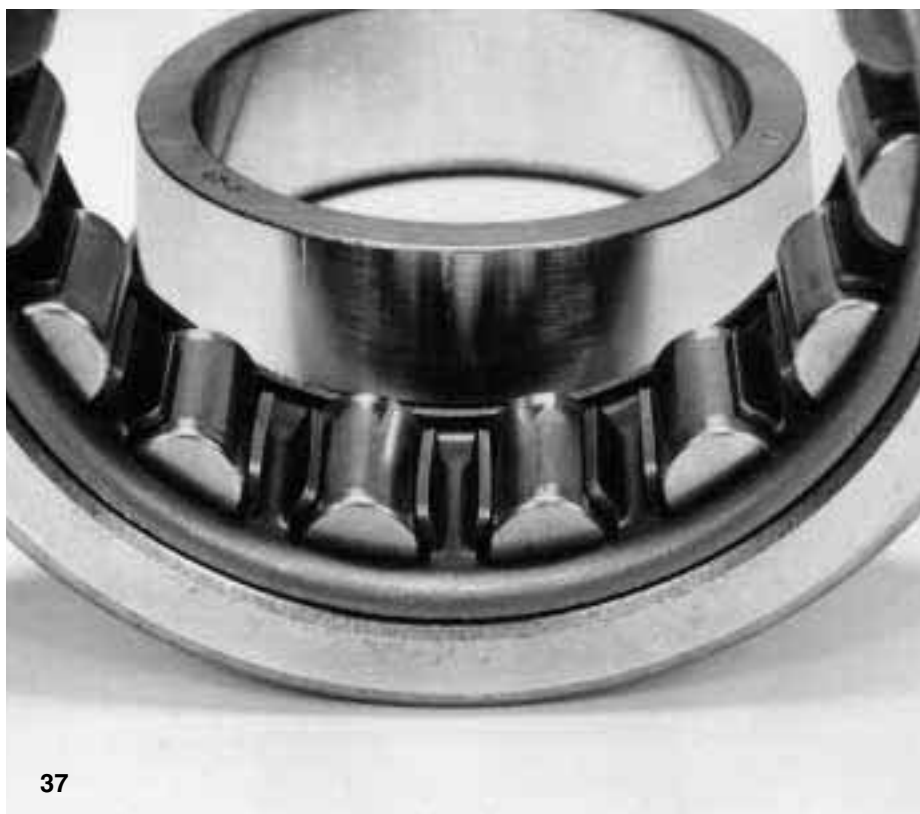
Fig 37 A cylindrical roller bearing with smear streaks in the inner ring raceway and on the rollers. The smearing has been caused by the roller assembly being entered askew without being rotated

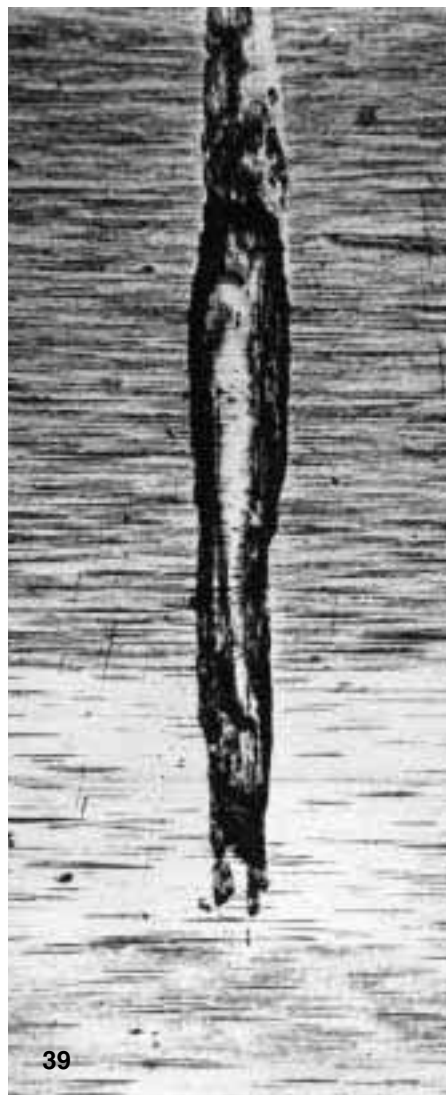
**Fig 38** Outer ring raceway of a spherical roller bearing with smear streaks caused by a blow against the inner ring

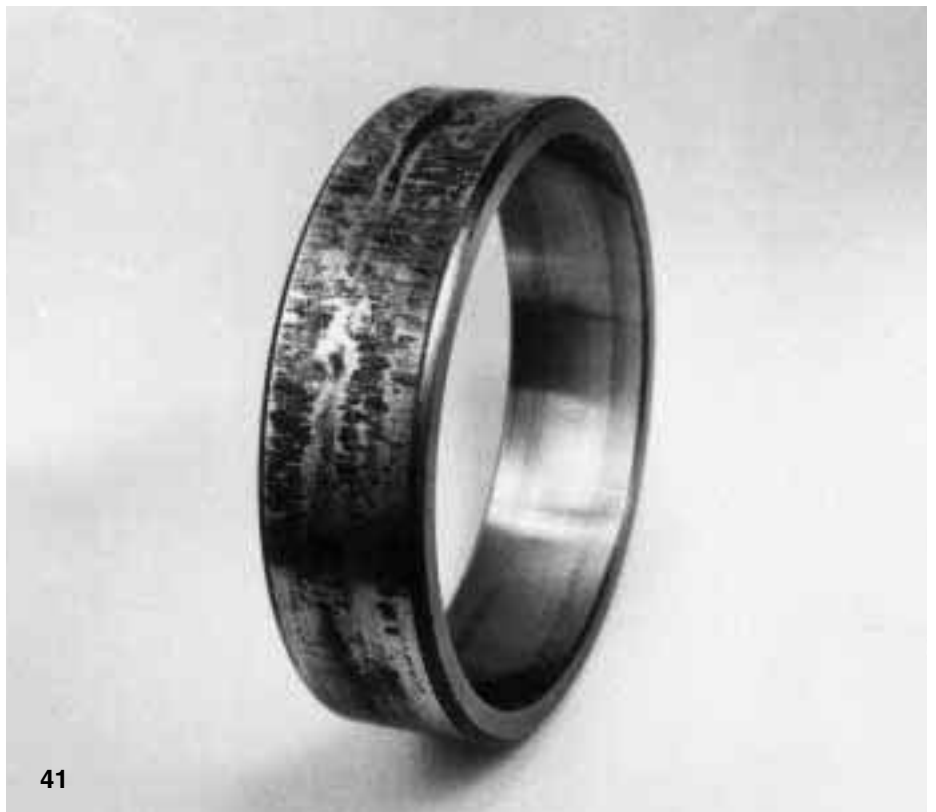
**Fig 40** Smeared face of a cylindrical roller bearing inner ring

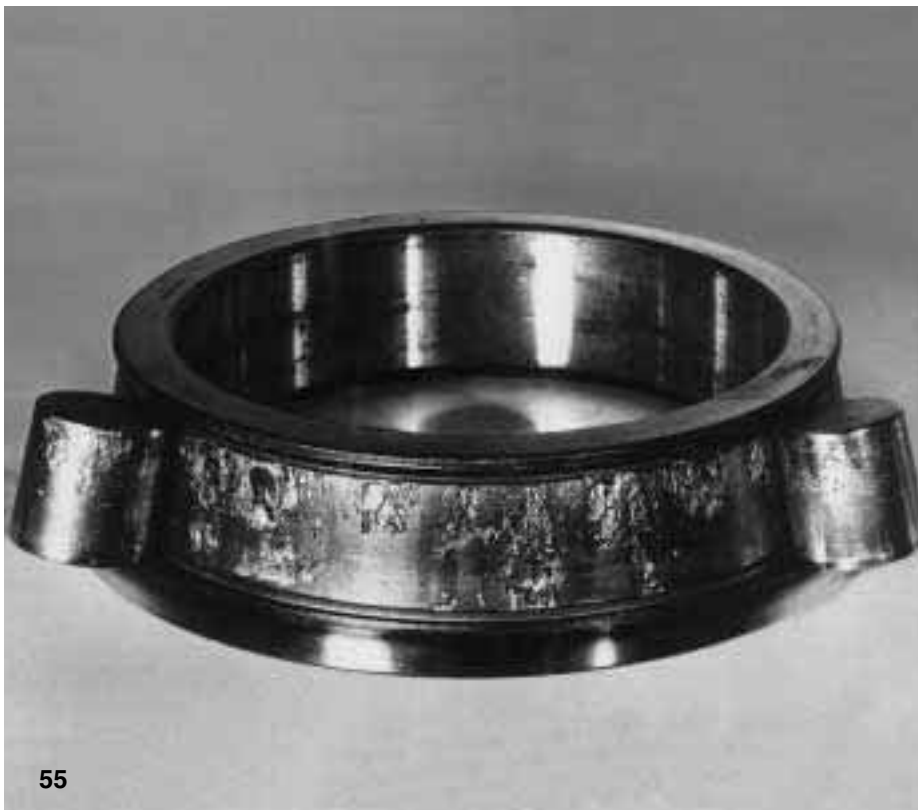
**Fig 55** Flaked cone and rollers of taper roller bearing. Heavy loading and inadequate lubrication are the causes of this damage

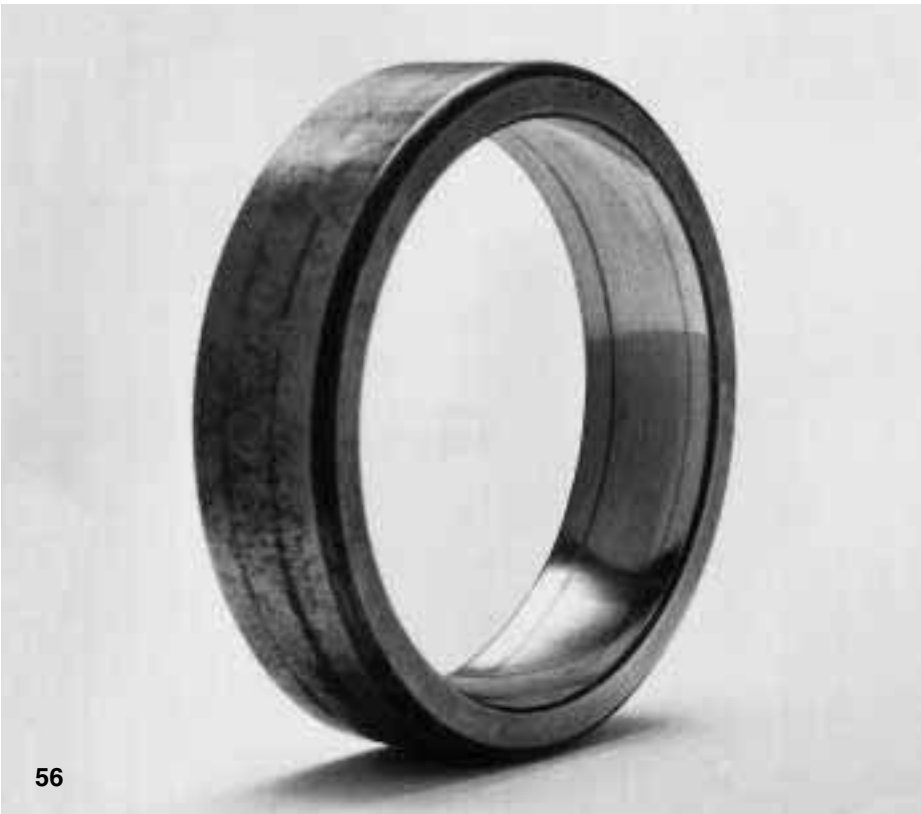
**Fig 56** Outer ring of a self-aligning ball bearing that has been driven too far up its tapered seating. The bearing had only performed a few revolutions when the damage was detected. Flaking would soon have occurred if the bearing had been put into service

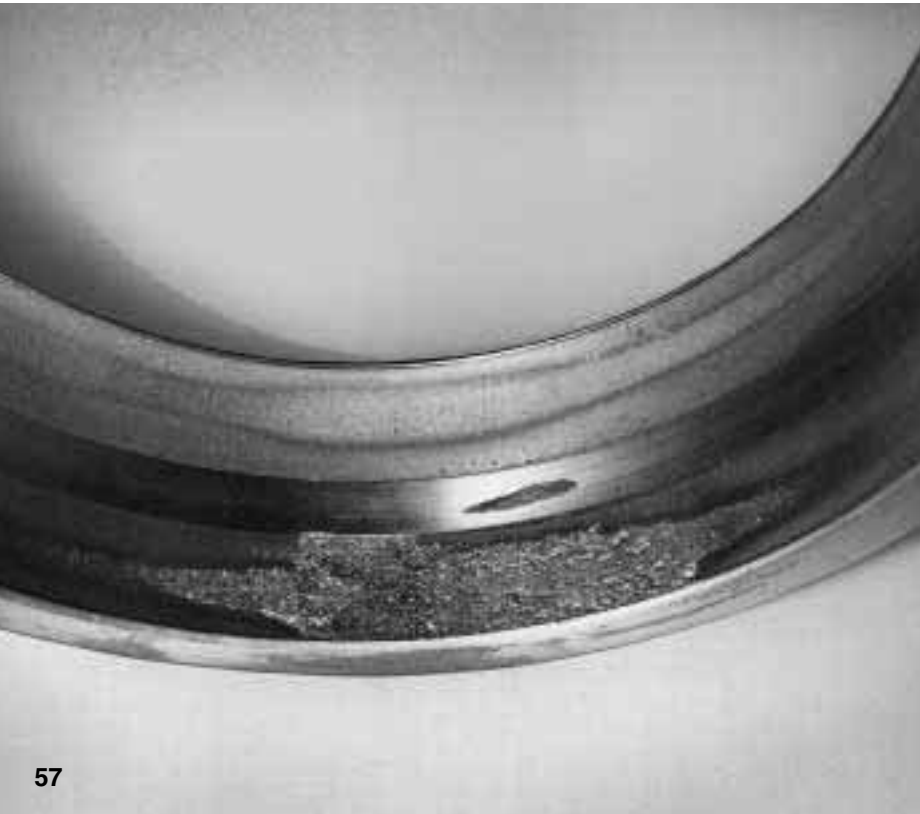
**Fig 57** Flaking in the outer ring outer ring of spherical roller bearing that has been mounted in a housing with oval bore

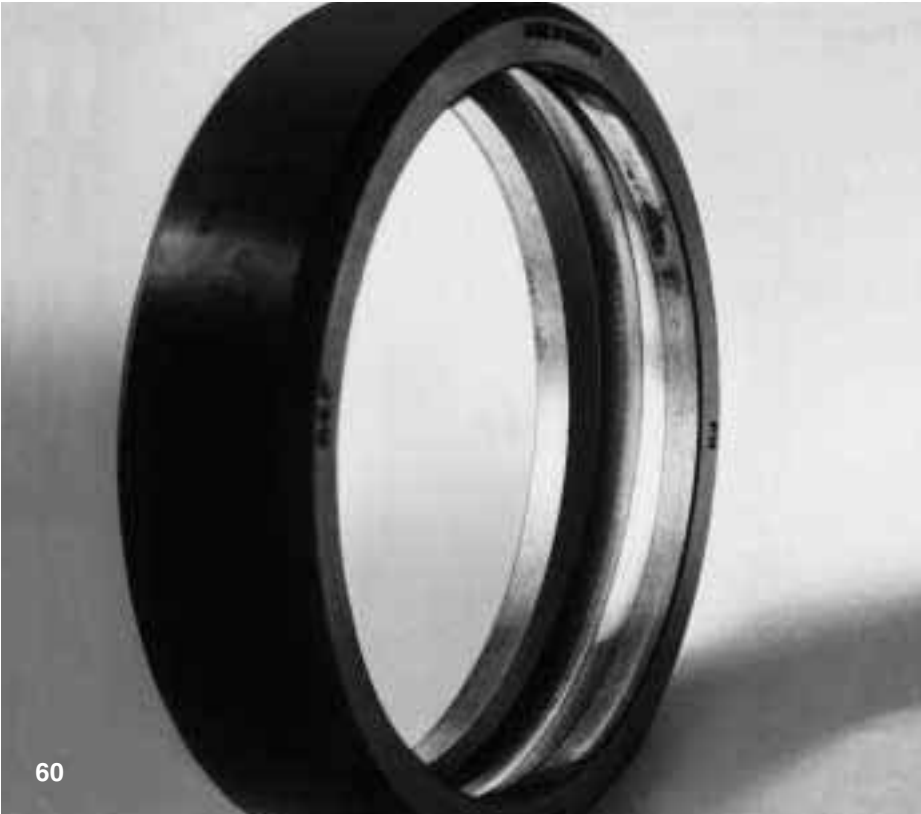
**Fig 60** Deep groove ball bearing outer ring that has been out of alignment with the shaft. The ball path has an oval configuration on account of the misalignment. The result is the same as with oval compression, see page 31

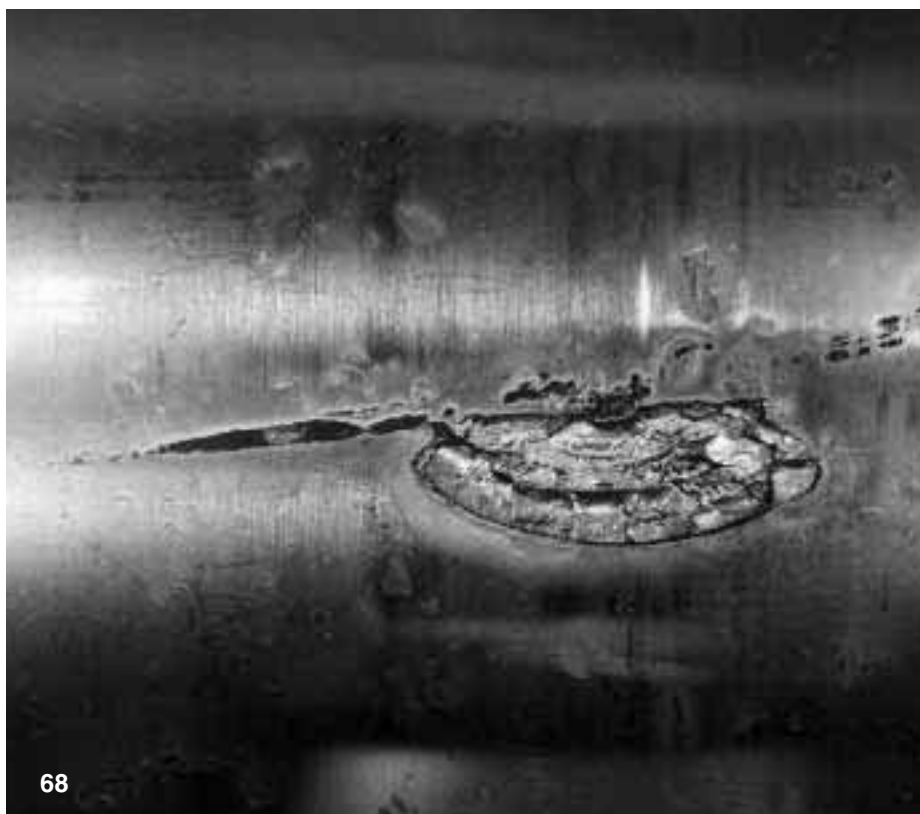
**Fig 68** Magnification of the damage shown in fig 66

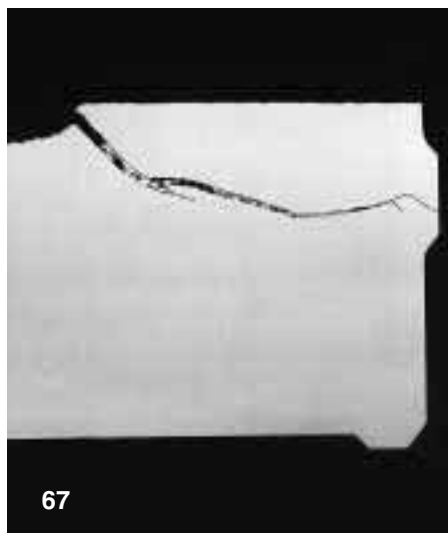
**Fig 67** Cross section through the roller depicted in fig 66, showing the way in which the fatigue crack extends beneath the surface. The fully developed flaking originated in the same manner

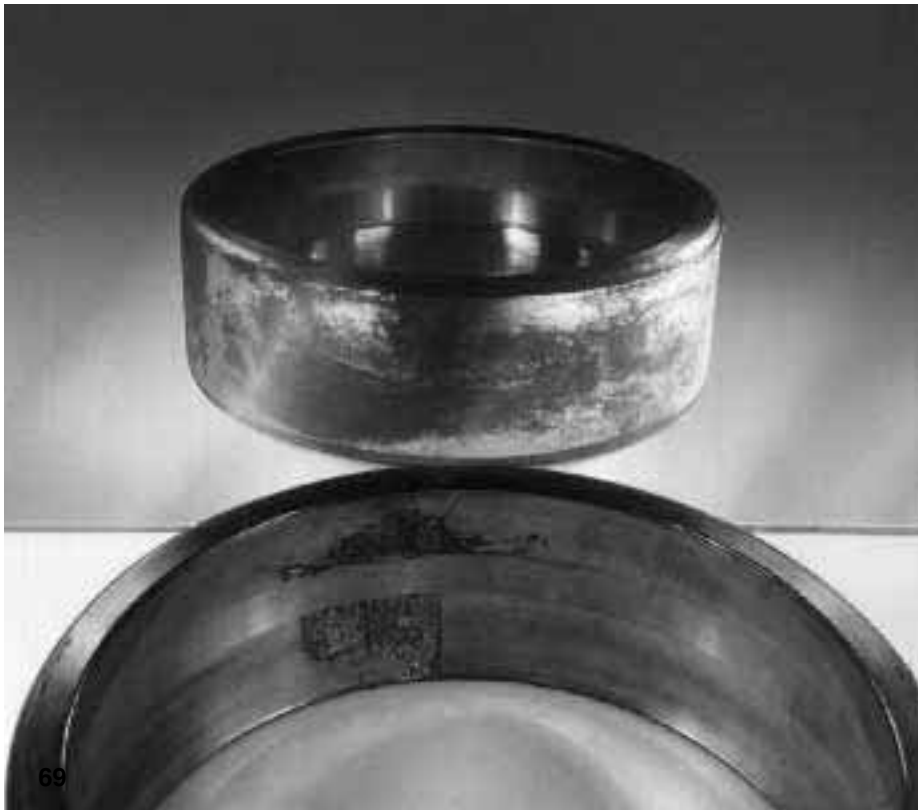
**Fig 69** Flaking in the raceways of the outer ring of a spherical roller bearing. Corresponding area of advanced fretting corrosion on the outside surface (for this photograph the ring has been placed in front of a mirror). Development of the corrosion has been accompanied by an increase in volume that has led to deformation of the bearing ring and localised overloading. The results have been premature fatigue and flaking

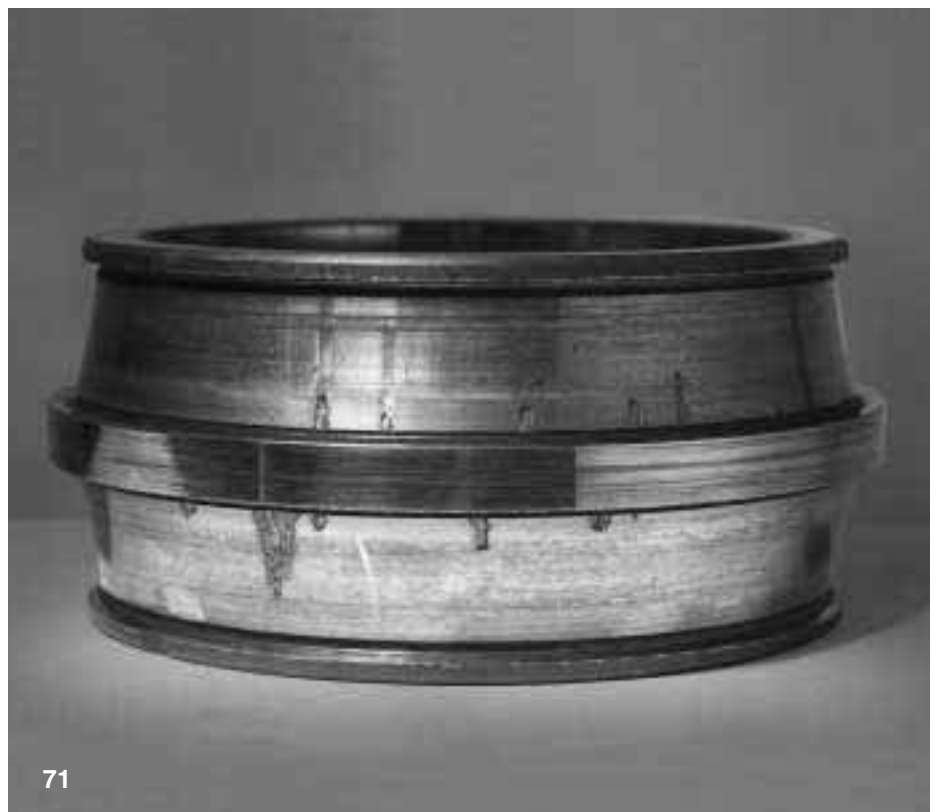
**Fig 71** Flaking in both raceways of the inner ring of a spherical roller bearing. The flaking has originated from the vibration markings
